**Flood Control Project Maintenance  
Levee Inspections**

## Maintenance Issue Types Only, Levee Inspection Report By Mile - Spring 2017

### Reclamation District No. 2062 Stewart

Waterway	Bank	Unit Miles	Inspection Start/End	Inspector
Unit No. 01 San Joaquin River	Left	2.64	03/29/2017 03/29/2017	Maksim Khashchuk

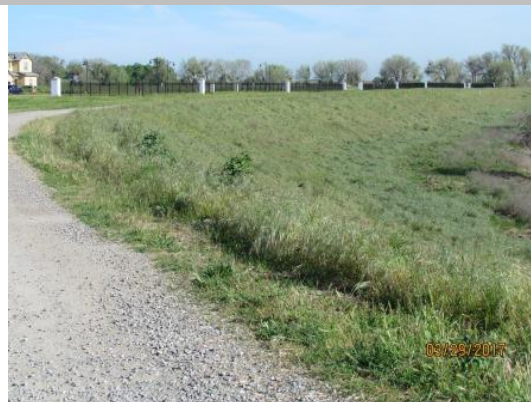
Photo 1 of 1 : SP\_2017\_RD2062\_309\_7\_20170405\_00012.jpg

LM Start	<b>0.04</b>	Rating **	M	Issue No.	<b>7</b>
LM End	<b>2.52</b>	Issue Type +	Ma	Location *	WS
Category	Earthen Levee		GPS Latitude/Longitude		
			Start	End	
Item	Vegetation		37.807181 °	37.788693 °	
			-121.327459 °	-121.308832 °	
DWR ID	DWR_RD2062_01_s_2017_7				
Comment Code					
V1 : Control annual grass and weeds on the levee slopes and easements.					
Inspector Comment

View of the vegetation on the levee slope.

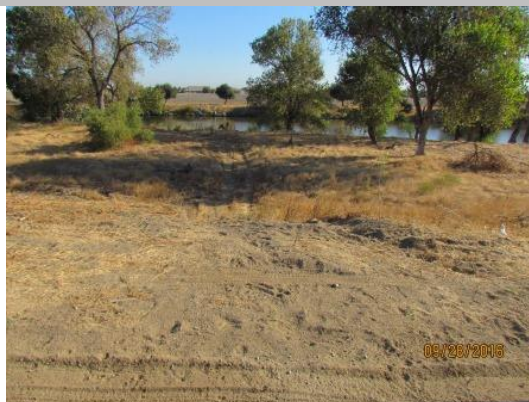
Photo 1 of 1 : SP\_2017\_RD2062\_309\_9\_20170313\_00002.jpg

LM Start	2.14	Rating **	M	Issue No.	9
LM End	2.14	Issue Type +	Ma	Location *	WS
Category	Earthen Levee			GPS Latitude/Longitude	
				Start	End
Item	Slope Stability			37.793991 °	37.793991 °
				-121.308524 °	-121.308524 °
DWR ID	DWR_RD2062_01_f_2016_9				
Comment Code					
S3 : Repair the levee slope damaged by vehicle traffic and prevent access where possible.					
Inspector Comment					
It is recommended to control levee access to prevent possible future damage to the levee slopes.

View of the waterside levee slope erosion due to vehicles driving on the slope.

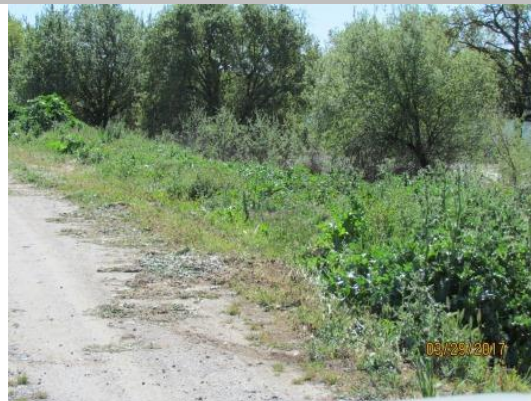
Photo 1 of 1 : SP\_2017\_RD2062\_310\_11\_20170405\_00027.jpg

LM Start	0.45	Rating **	U	Issue No.	11
LM End	3.81	Issue Type +	Ma	Location *	WS
Category	Earthen Levee			GPS Latitude/Longitude	
				Start	End
Item	Vegetation			37.783106 °	37.807388 °
				-121.337791 °	-121.389491 °
DWR ID	DWR_RD2062_02_s_2017_11				
Comment Code					
V1 : Control annual grass and weeds on the levee slopes and easements.					
Inspector Comment

View of the vegetation on the levee slope.

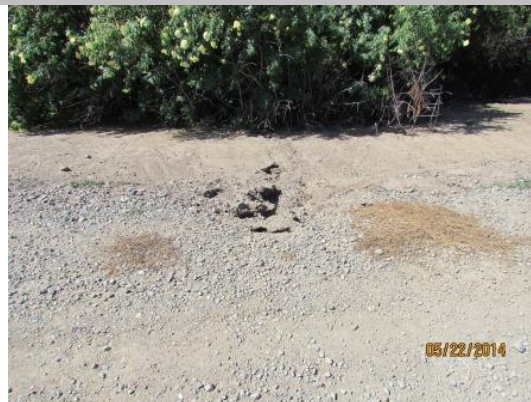
Photo 1 of 1 : SP\_2017\_RD2062\_310\_8\_20170313\_00001.jpg

LM Start	3.64	Rating **	M	Issue No.	8
LM End	3.64	Issue Type +	Ma	Location *	WS
Category	Earthen Levee			GPS Latitude/Longitude	
				Start	End
Item	Erosion / Bank Caving			37.806347 °	37.806347 °
				-121.386692 °	-121.386692 °
DWR ID	DWR_RD2062_02_s_2014_8				
Comment Code					
E2 : Schedule repair of erosion site prior to the next inspection.					
Inspector Comment

View of the erosion from surface runoff on the waterside levee slope.

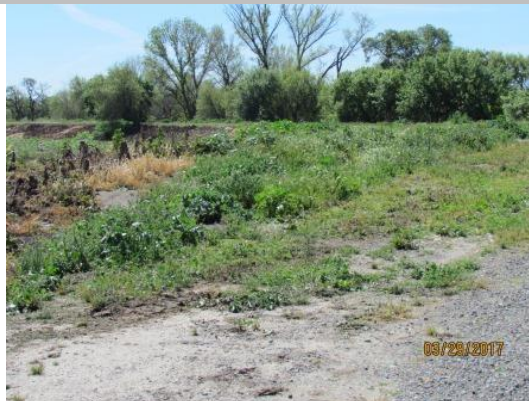
Photo 1 of 1 : SP\_2017\_RD2062\_310\_10\_20170405\_00026.jpg

LM Start	3.90	Rating **	U	Issue No.	10
LM End	3.95	Issue Type +	Ma	Location *	LS
Category	Earthen Levee			GPS Latitude/Longitude	
				Start	End
Item	Vegetation			37.808444 °	37.809195 °
				-121.390435 °	-121.390408 °
DWR ID	DWR_RD2062_02_s_2017_10				
Comment Code					
V1 : Control annual grass and weeds on the levee slopes and easements.					
Inspector Comment

View of the vegetation on the levee slope.

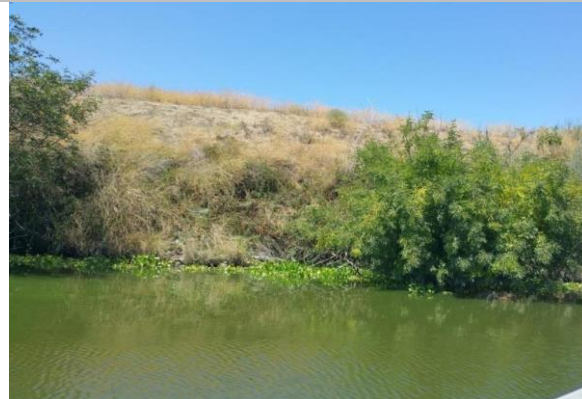
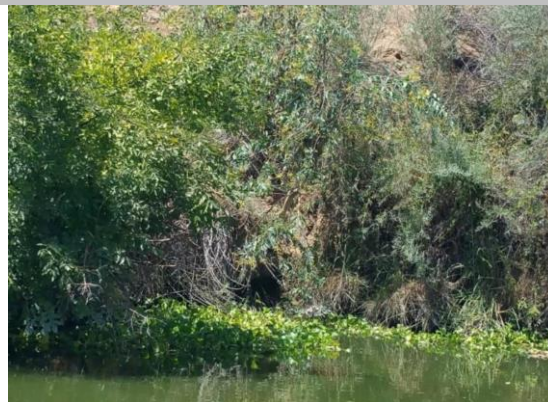
LM Start	-0.04	Rating **	U	Issue No.	1
LM End	0.06	Issue Type +	Ma	Location *	WS
Category	Supplemental			GPS Latitude/Longitude	
				Start	End
Item	DWR Erosion Survey			37.809414 °	37.809414 °
				-121.390328 °	-121.390328 °
DWR ID	DWR_RD2062_03_s_2017_1				
Comment Code					
Inspector Comment					
07/25/2016: No significant change observed.					
06/25/2015: No significant change observed.					
07/02/2014: No significant change observed.					
08/13/2013: No significant change observed.					
08/07/2012: The site has been visited by boat survey. No significant change observed					
08/23/2011: Site is at the upstream of a drainage ditch. [2016 Site ID:RD2062U03RM29.93]

Front view of the erosion.

Close view of the erosion.

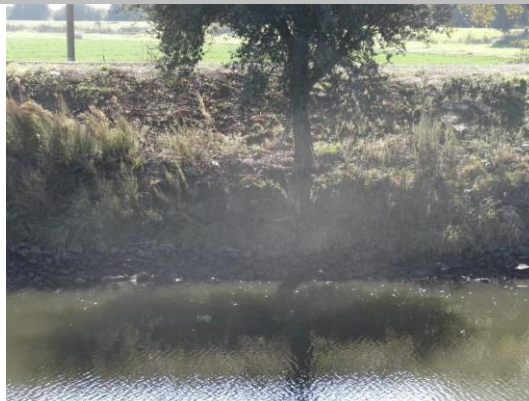
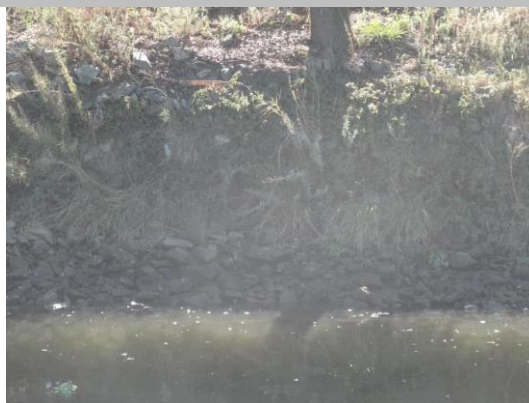
LM Start	0.02	Rating **	M	Issue No.	2
LM End	0.03	Issue Type +	Ma	Location *	WS
Category	Supplemental			GPS Latitude/Longitude	
				Start	End
Item	DWR Erosion Survey			37.809514 °	37.809514 °
				-121.390125 °	-121.390125 °
DWR ID	DWR_RD2062_03_s_2017_2				
Comment Code					
Inspector Comment					
11/09/2016: No significant change observed.					
06/25/2015: The erosion is below a large oak tree. Vegetation is visible around the erosion site. [2016 Site ID:RD2062U03RM29.94]

Front view of the erosion site. Note the large tree above the erosion.

Close view of the erosion.

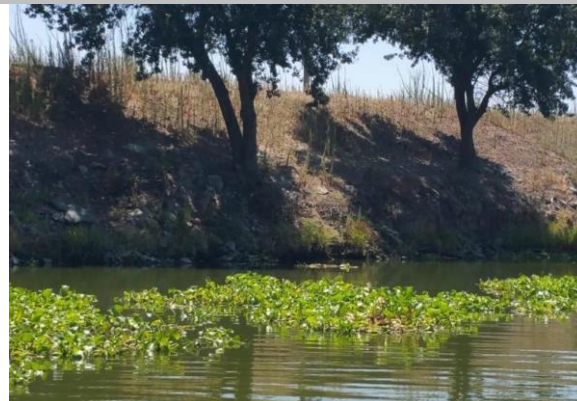
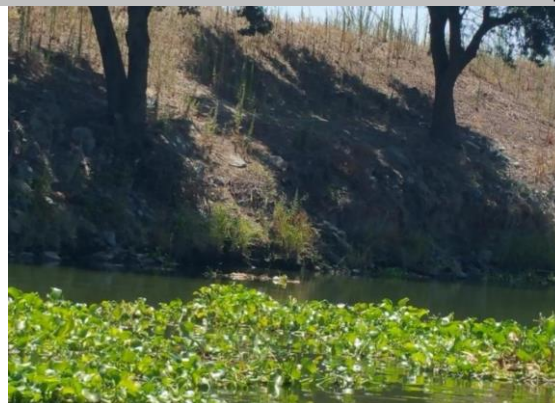
LM Start	0.10	Rating **	U	Issue No.	4
LM End	0.11	Issue Type +	Ma	Location *	WS
Category	Supplemental			GPS Latitude/Longitude	
				Start	End
Item	DWR Erosion Survey			37.809932 °	37.809932 °
				-121.388788 °	-121.388788 °
DWR ID	DWR_RD2062_03_s_2017_4				
Comment Code					
Inspector Comment					
07/25/2016: No significant change observed.					
06/25/2015: No significant change observed.					
07/02/2014: No significant change observed.					
08/13/2013: No significant change observed.					
08/07/2012: The site has been visited by boat survey. No significant change observed					
08/23/2011: Hard to view the erosion because of the dense vegetation and trees on site. The site is under the bush, close to the tree. [2016 Site ID:RD2062U03RM30.02]

Front view of the site.

Close view of the site. Note vegetation at the site.

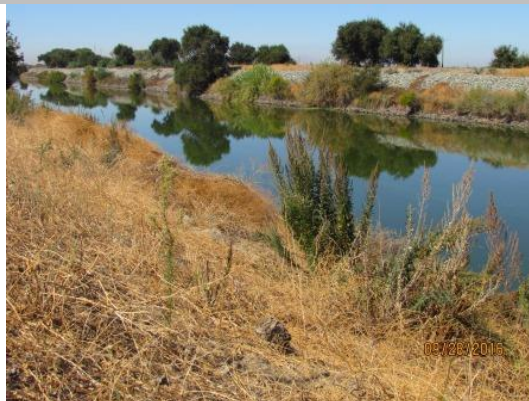
Photo 1 of 1 : SP\_2017\_RD2062\_311\_6\_20170313\_00009.jpg

LM Start	0.17	Rating **	N	Issue No.	6
LM End	0.17	Issue Type +	Ma	Location *	WS
Category	Earthen Levee			GPS Latitude/Longitude	
				Start	End
Item	Trim / Thin Trees			37.810194 °	37.810194 °
				-121.387602 °	-121.387602 °
DWR ID	DWR_RD2062_03_s _ 2012_6				
Comment Code					
T5 : Tree stumps.					
Inspector Comment

View of the tree stump on the waterside levee slope.

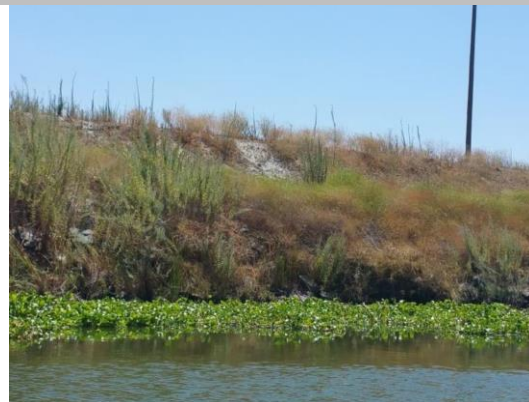
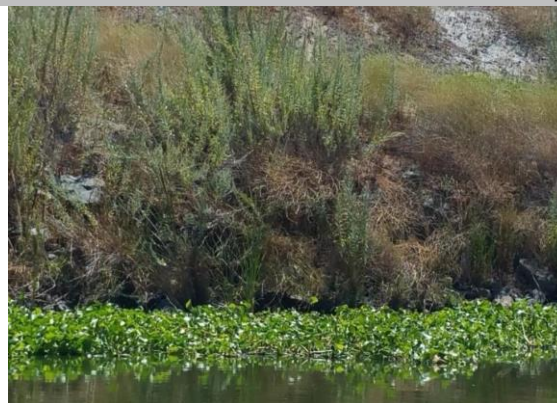
LM Start	0.17	Rating **	M	Issue No.	5
LM End	0.17	Issue Type +	Ma	Location *	WS
Category	Supplemental			GPS Latitude/Longitude	
				Start	End
Item	DWR Erosion Survey			37.810268 °	37.810268 °
				-121.387495 °	-121.387495 °
DWR ID	DWR_RD2062_03_s _ 2017_5				
Comment Code					
Inspector Comment					
07/25/2016: No significant change observed.					
06/25/2015: No significant change observed.					
07/02/2014: No significant change observed.					
08/13/2013: No significant change observed.					
08/07/2012: The site has been visited by boat survey. No significant change observed					
08/23/2011: The protection at the levee toe has been washed away.					
[2016 Site ID:RD2062U03RM30.1]

Direct view of the site.

Close view of the erosion.

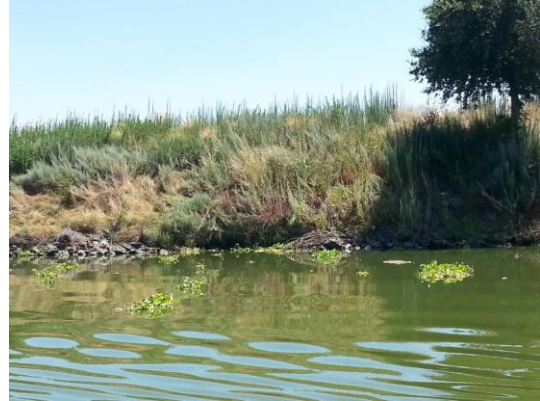
Photo 1 of 1 : SP\_2017\_RD2062\_311\_8\_20170313\_00010.jpg

LM Start	0.22	Rating **	U	Issue No.	8
LM End	0.31	Issue Type +	Ma	Location *	WS
Category	Supplemental			GPS Latitude/Longitude	
				Start	End
Item	DWR Erosion Survey			37.810609 °	37.810609 °
				-121.385879 °	-121.385879 °
DWR ID	DWR_RD2062_03_s_2017_8

Comment Code					
Inspector Comment					
07/25/2106: No significant change observed. More vegetation observed at the site.					
06/25/2015: No significant change observed.					
07/02/2014: No significant change observed.					
08/13/2013: A new pocket erosion at the upper levee slope has been found directly above a large tree. The erosion might have been caused by internal pipe leakage or surface runoff.					
08/07/2012: The site has been visited by boat survey. No significant change observed					
08/23/2011: No significant change observed on site. Dense vegetation is visible along the water line.					
09/07/2010: No significant change observed on site. Much of the upper slope was recently cleared of vegetation by spraying. 4- to 6-foot vertical scarp and pocket erosions are lined along a span of 475 feet. In some sections, the vertical scarp encroaches into the levee prism. There is a lack of berm along this reach, exposing the levee slope to high flow velocities during normal and flood events.

08/06/2010: Recommended as local maintenance issue, per CLRO.					
03/09/2010: As discussed with Michael Moncrief of MBK Engineers, the site will be 'addressed' later this year.					
09/29/2009: No major change observed since last visit; pocket erosion and a vertical scarp forming; this site was combined with Site RM30.13 and 30.02 with a combined total erosion length of 475 feet; recommended as annual assessment and monitoring of the site, per CLRO CES Evaluation 2008 Report; previously rated "M".					
11/05/2008: Top of vertical scarp has rip rap that appears to be sliding; rodent holes; existing toe rip rap. [2016 Site ID:RD2062U03RM30.19]

Close view of the pocket erosion. Note the dense vegetation at the site.

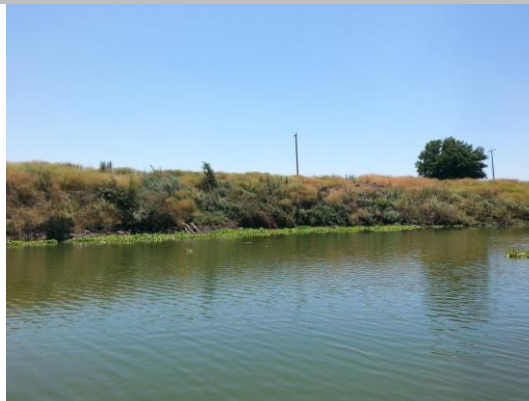
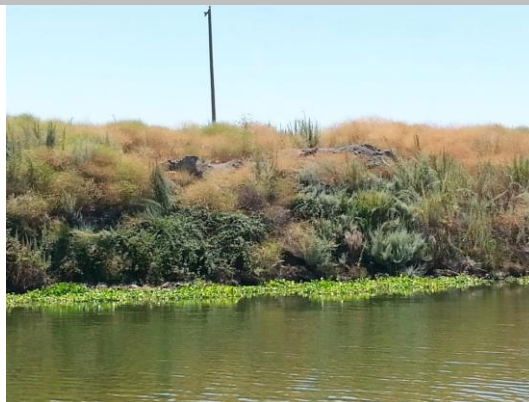
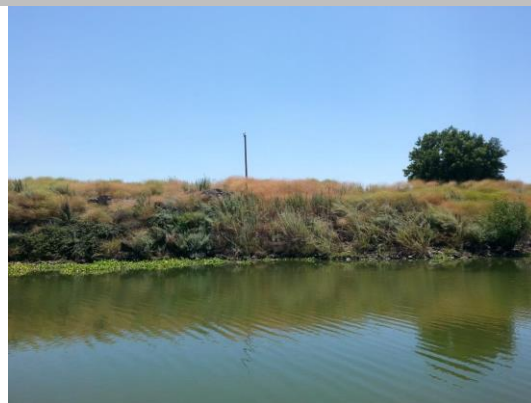
LM Start	0.35	Rating **	M	Issue No.	9	
LM End	0.35	Issue Type +	Ma	Location *	WS	
Category	Supplemental			GPS Latitude/Longitude		
				Start	End	
Item	DWR Erosion Survey			37.811101	°	37.811101
				-121.384402	°	-121.384402
DWR ID	DWR_RD2062_03_s_2017_9					
Comment Code						
Inspector Comment						
07/25/2016: No significant change observed.						
06/25/2015: No significant change observed.						
07/02/2014: No significant change observed.						
08/13/2013: No significant change observed.						
08/07/2012: The site has been visited by boat survey. No significant change observed						
08/23/2011: The site is right at the downstream of a river bend. [2016 Site ID:RD2062U03RM30.27]

Front view of the erosion.

Close view of the site. Note the dense vegetation at the site.

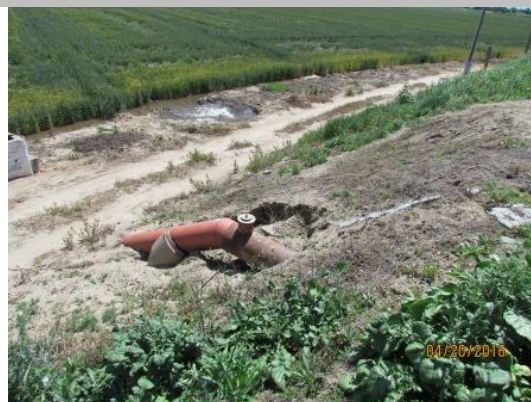
Photo 1 of 1 : SP\_2017\_RD2062\_311\_38\_20170313\_00023.jpg

LM Start	0.51	Rating **	M	Issue No.	38
LM End	0.51	Issue Type +	Ma	Location *	LS
Category	Earthen Levee			GPS Latitude/Longitude	
				Start	End
Item	Erosion / Bank Caving			37.812552 °	37.812552 °
				-121.382781 °	-121.382781 °
DWR ID	DWR_RD2062_03_s_2016_38				
Comment Code					
E2 : Schedule repair of erosion site prior to the next inspection.					
Inspector Comment

View of the landside levee slope erosion around the pipe.

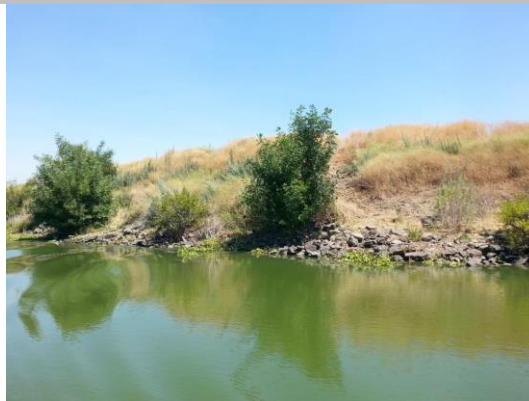
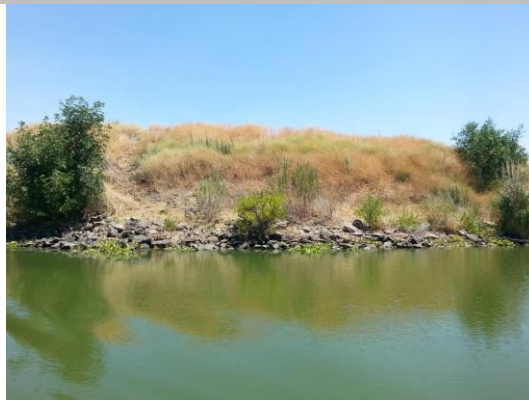
LM Start	<b>0.55</b>	Rating **	M	Issue No.	<b>13</b>
LM End	<b>0.56</b>	Issue Type +	Ma	Location *	WS
Category	Supplemental		GPS Latitude/Longitude		
			Start	End	
Item	DWR Erosion Survey		37.813070 °	37.813070 °	
			-121.383100 °	-121.383100 °

07/25/2016: No significant change observed.  
 06/25/2015: No significant change observed.  
 07/02/2014: No significant change observed.  
 08/13/2013: No significant change observed.  
 08/07/2012: The site has been visited by boat survey. No significant change observed.  
 08/23/2011: No significant change observed on site.  
 09/07/2010: No significant change observed on site. Much of the placed rip rap revetment has slid. It is no longer adequately protecting the slope.  
 08/06/2010: Recommended as local maintenance issue, per CLRO Report.  
 03/09/2010: As discussed with Michael Moncrief of MBK, site will be 'addressed' this year.  
 09/29/2009: No major change observed since last visit; a section of the rip rap has slipped, exposing a levee section that has eroded; recommended as local maintenance issue, per CLRO CES Evaluation 2008 Report; Site # is the same as RM30.43, LM0.63; previously rated "U".

11/05/2008: Site is located inside of a bend; scarp looks to be into the levee prism; piles of concrete chunks placed on the slope, with some of them already starting to slide. [2016 Site ID:RD2062U03RM30.43]

Front view of the site. Previously placed rip rap slipped, exposing the underlying soils and creating a pocket.

Front view of the site. Rip rap is no longer adequately protecting levee slope.

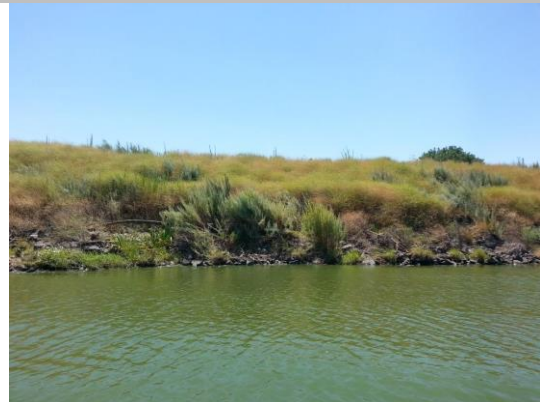
Photo 1 of 1 : SP\_2017\_RD2062\_311\_17\_20170313\_00016.jpg

Comment Code					
Inspector Comment					
07/25/2016: No significant change observed.					
06/25/2015: No significant change observed.					
07/02/2014: No significant change observed.					
08/13/2013: No significant change observed.					
08/07/2012: The site has been visited by boat survey. No significant change observed					
08/23/2011: No significant change observed on site.					
09/07/2010: No significant change observed on site. Much of the seasonal grass along the slope was cleared. Site consists of an existing scalloped erosion approximately 30 feet long by 5 feet wide at its widest opening. The lateral crack is extended outwards along the middle slope. There is a 1 to 2 feet of differential settlement that could further develop into a shallow slide.					
08/06/2010: Recommended as local maintenance issue, per CLRO.					
03/09/2010: As discussed with Michael Moncrief of MBK Engineer, site will be 'addressed' this year.

09/28/2009: No major change observed; section of rip rap has slipped, creating a terraced effect; dense vegetation growth; recommended as a local maintenance issue, per CLRO CES Evaluation 2008 Report; Site # is the same as RM31.12,LM1.25; previously rated "U".					
09/14/2006: 1-2' into prism. [2016 Site ID:RD2062U03RM31.12]

Front view of the site.

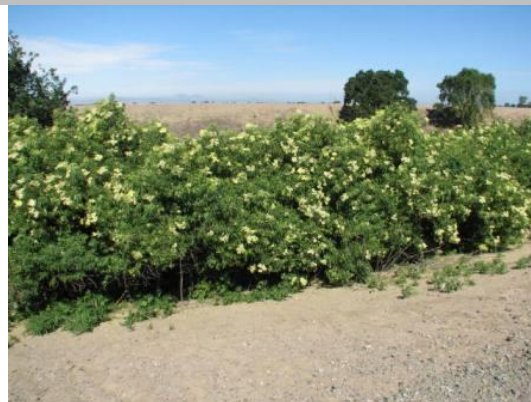
Photo 1 of 1 : SP\_2017\_RD2062\_311\_18\_20170313\_00017.jpg

05/11/2011 Elderberry bush on water side slope.

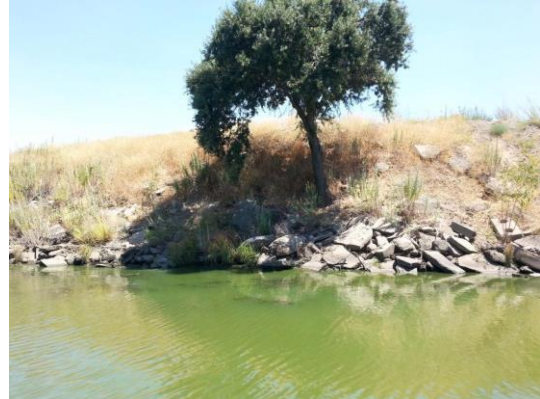
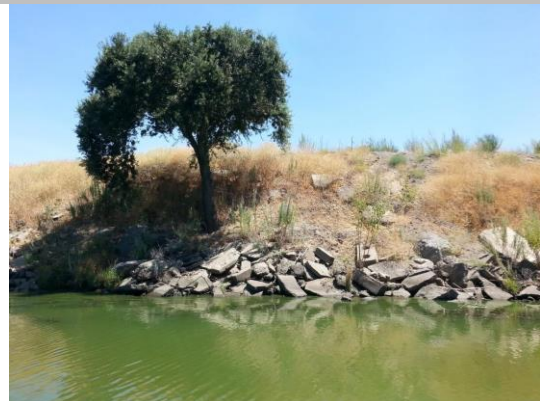
07/25/2016: No significant change observed.  
 06/25/2015: No significant change observed.  
 07/02/2014: No significant change observed.  
 08/13/2013: No significant change observed.  
 08/07/2012: The site has been visited by boat survey. No significant change observed  
 08/23/2011: No significant change observed on site.  
 09/07/2010: No significant change observed on site. There is a small- to medium sized Oak tree on the mid-slope just above rip rap. Some of the rip rap has collapsed, creating a pocket erosion just above the existing toe rip rap and upstream of the Oak tree.  
 08/06/2010: Recommended as local maintenance issue, per CLRO.  
 03/09/2010: As discussed with Michael Moncrief of MBK Engineer, site will be 'addressed' in 2010.  
 09/29/2009: No major change since last visit; sliding of the rip rap at the base of the lone tree; there is noticeable man-made trail and foot traffic extending from the crown to the toe; much of the broken concrete used as temporary rip rap has slid, exposing portion of the bare levee slope; recommended as local maintenance issue, per CLRO CES Evaluation 2008 Report; Site # is the same as RM31.3, LM1.45; previously rated "M".

Front view of the erosion site.

Front view of the site. Note the existing broken concrete on the upper levee slope as well as on the lower slope and at the toe.

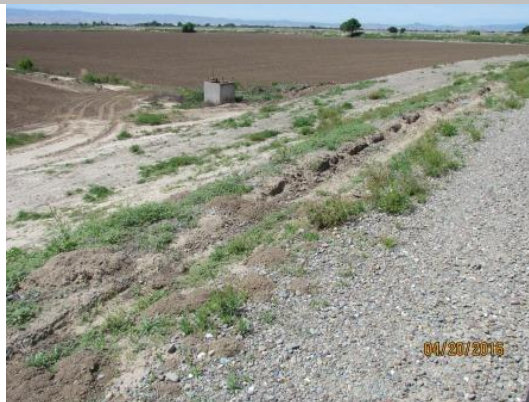
Photo 1 of 1 : SP\_2017\_RD2062\_311\_29\_20170313\_00018.jpg

View of a tire rut on the landside levee hinge.

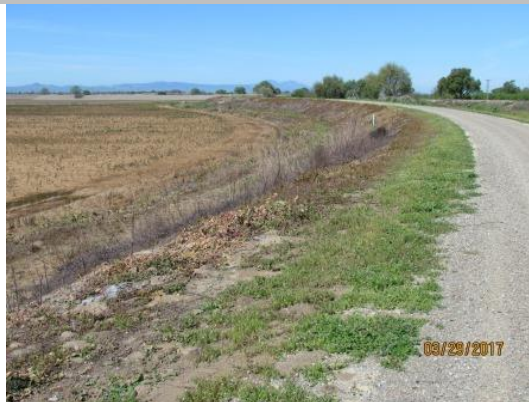
Photo 1 of 1 : SP\_2017\_RD2062\_311\_41\_20170405\_00047.jpg

LM Start	1.66	Rating **	M	Issue No.	41
LM End	1.82	Issue Type +	Ma	Location *	LS
Category	Earthen Levee			GPS Latitude/Longitude	
				Start	End
Item	Vegetation			37.820863 °	37.820481 °
				-121.372277 °	-121.369421 °
DWR ID	DWR_RD2062_03_f_2016_41				
Comment Code					
V1 : Control annual grass and weeds on the levee slopes and easements.					
Inspector Comment

View of the vegetation on the landside levee slope.

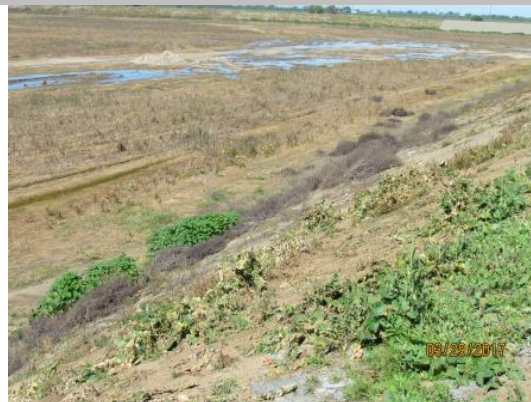
Photo 1 of 1 : SP\_2017\_RD2062\_311\_39\_20170405\_00045.jpg

View of the vegetation at the landside levee toe.

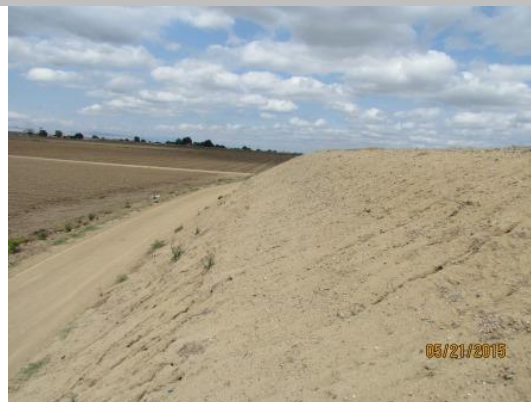
Photo 1 of 1 : SP\_2017\_RD2062\_311\_31\_20170313\_00019.jpg

LM Start	3.61	Rating **	M	Issue No.	31
LM End	3.66	Issue Type +	Ma	Location *	LS
Category	Earthen Levee			GPS Latitude/Longitude	
				Start	End
Item	Erosion / Bank Caving			37.816982 °	37.816541 °
				-121.342939 °	-121.342191 °
DWR ID	DWR_RD2062_03_s_2015_31				
Comment Code					
E2 : Schedule repair of erosion site prior to the next inspection.					
Inspector Comment					
About a 3 ft vertical cut at the levee toe into the levee prism.

View of the eroded landside levee toe.

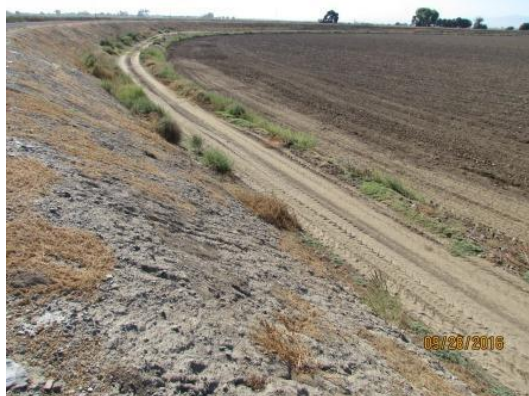
Photo 1 of 1 : SP\_2017\_RD2062\_311\_37\_20170313\_00022.jpg

LM Start	4.30	Rating **	M	Issue No.	37
LM End	4.35	Issue Type +	Ma	Location *	LS
Category	Earthen Levee			GPS Latitude/Longitude	
				Start	End
Item	Erosion / Bank Caving			37.819436 °	37.819096 °
				-121.335469 °	-121.334829 °
DWR ID	DWR_RD2062_03_f_2016_37				
Comment Code					
E2 : Schedule repair of erosion site prior to the next inspection.					
Inspector Comment					
Toe road encroaches into the levee toe.

View of the toe road encroaching into the levee prism.

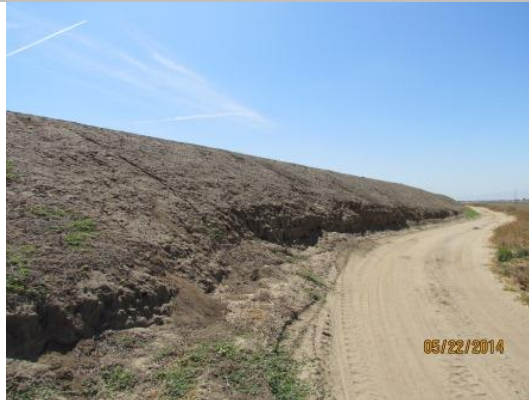
Photo 1 of 1 : SP\_2017\_RD2062\_311\_35\_20170313\_00020.jpg

LM Start	4.83	Rating **	M	Issue No.	35
LM End	4.91	Issue Type +	Ma	Location *	LS
Category	Earthen Levee			GPS Latitude/Longitude	
				Start	End
Item	Erosion / Bank Caving			37.812849 °	37.811682 °
				-121.336116 °	-121.336271 °
DWR ID	DWR_RD2062_03_f_2014_35				
Comment Code					
E2 : Schedule repair of erosion site prior to the next inspection.					
Inspector Comment					
2 to 3 feet vertical cut possibly caused by previous floods.

View of a 2-3 feet vertical cut at the landside levee toe.
